## Ecological Condition: Moderate-low

### Summary

## General description

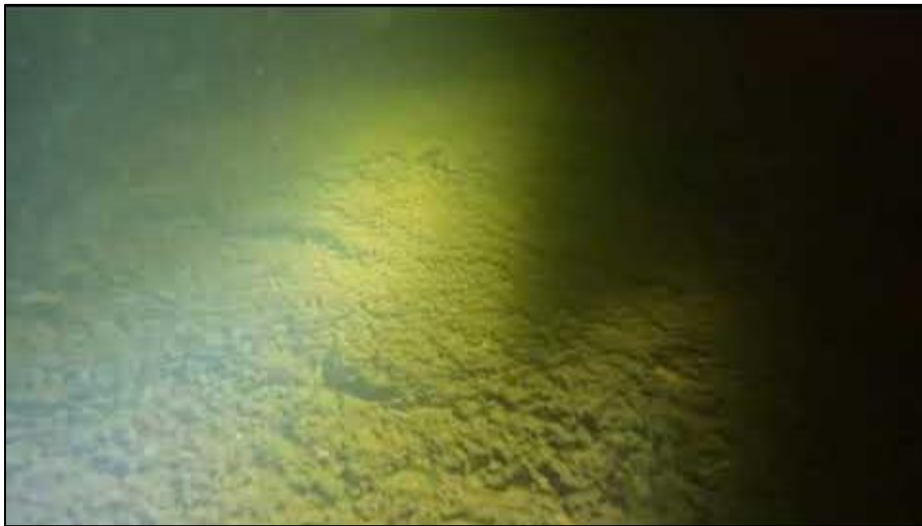
The 2026 survey indicates Lake Egg is currently devegetated (Video 1), with no submerged macrophyte beds and only occasional small strands of *Utricularia gibba* and clumps of *Azolla pinnata* amongst the emergent reeds. This represents a major structural change from the 2021 assessment where the lake supported a near-continuous surface reaching biomass of hornwort (*Ceratophyllum demersum*).

The decomposing hornwort post herbicide application combined with a high suspended algal biomass has created a thick layer (~0.8 m) of organic floc on the lakebed. This layer of unconsolidated organic material is actively inhibiting macrophyte establishment by creating poor rooting conditions (Video 1).

**Video 1:** Devegetated lakebed with a thick layer of organic floc.

Given the scale of degradation and complete loss of vegetation, recovery is likely to require a long-term restoration approach rather than short-term intervention alone. A long-term restoration plan could involve the use of flocculants and phosphorus sequestration to clarify the lake and stabilise the trophic state. This would create a period where the photic depth would extend to the lakebed. The increased photic depth would provide a suitable light climate for the re-introduction of native macrophytes. Tall fast growing vascular species (native pondweeds) are recommended as the colonisers followed by native charophytes.

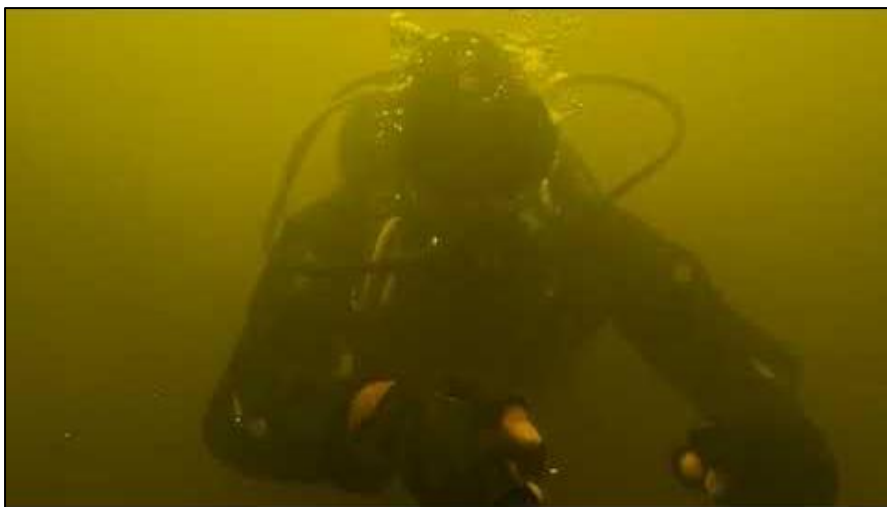
The current eutrophic state has resulted in the formation of distinct midwater sulphide layer above the thermocline, which effectively excludes light from reaching the lakebed (Video 2). This adds persistent macrophyte limiting pressure to the system.

**Video 2:** Diver ascending through midwater sulphide layer.
