## Ecological Condition: High

### Summary

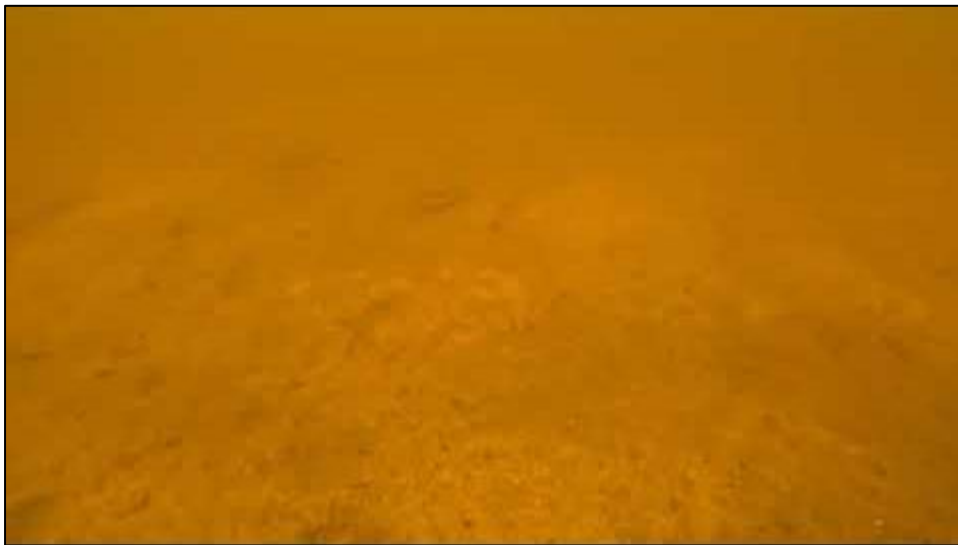
Lake Rotoroa remains in a moderate but impacted macrophyte assemblage. The current LakeSPI score indicates an improvement in macrophyte condition since 2021, primarily because invasive dominance has weakened and shallow native components are more evident. Despite this, the lake is still characterised by large devegetated areas (Video 1), high discontinuity of submerged habitat, and strong constraints from light limitation and unstable, organic-rich substrates, which collectively prevent the development of lake-wide bed-forming vegetation.

**Video 1:** Large devegetated sections of lakebed.

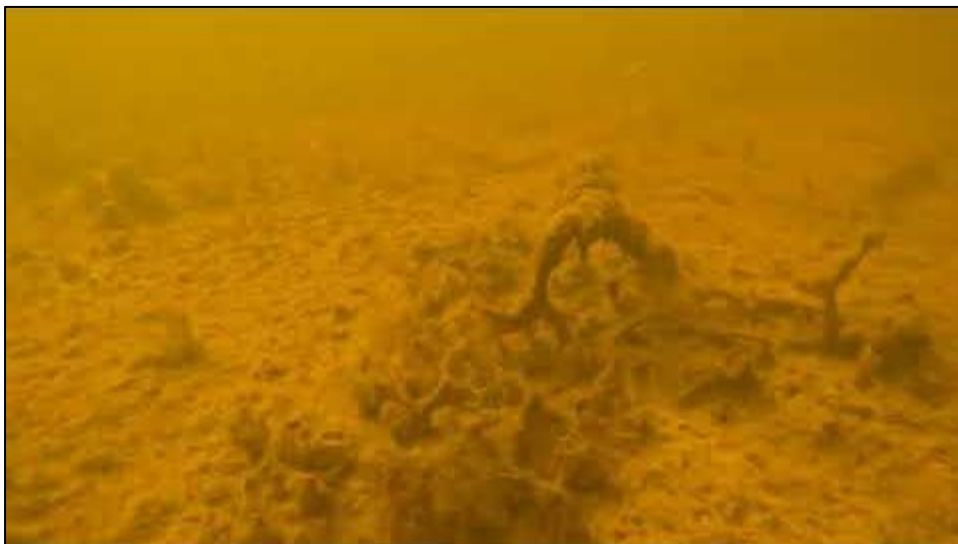
Macrophyte condition during the 2026 survey was poor with thick epiphyton growth on remnant vegetation, consistent with eutrophic stress (Video 2). From ~2.5 m depth, the benthos shifts to 80 – 90% cover of benthic algae, with the substrate becoming loose soft silt with a surficial layer of organic floc. These conditions that are generally unsuitable for macrophyte rooting and persistence. Water clarity was ~0.5 – 1.0 m, with a marked drop beyond ~2.1 m attributed to tannins. As a result, the estimated photic depth was ~1.5 - 1.8 m. Collectively, low photic depth, poor substrate quality, and eutrophication-associated effects are dominant constraints on macrophyte recovery in this lake.

**Video 2:** Representative macrophyte growth in poor condition along the edge of the emergent reeds.

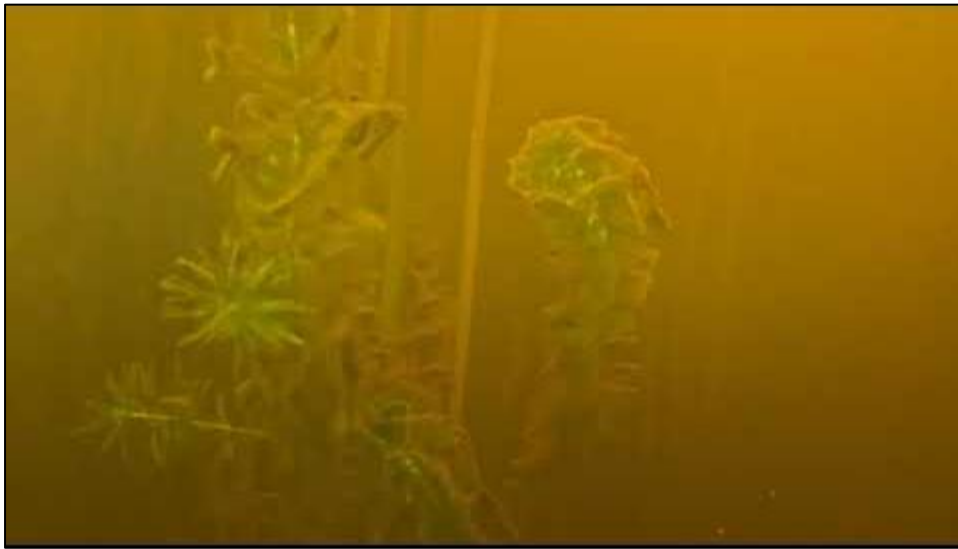
*Egeria* is currently still present and widespread but no longer forms continuous dominant beds. During the 2026 assessment it was recorded at low–moderate maximum cover

(~26%) with an average cover of 1 – 5%. Taller stands were detected amongst the emergent vegetation along the norther lake margin (Video 3).

**Video 3:** Tall *Egeria densa* amongst the emergent vegetation.

Alligator weed control is recommended where possible as well as continued surveillance so new incursions are detected early (manual removal is possible with the current extent). *Egeria* cover is moderate so manual removal, and localised matting could be effective control measures. Hunting-related biosecurity should be strengthened through equipment hygiene messaging and lake-user awareness.

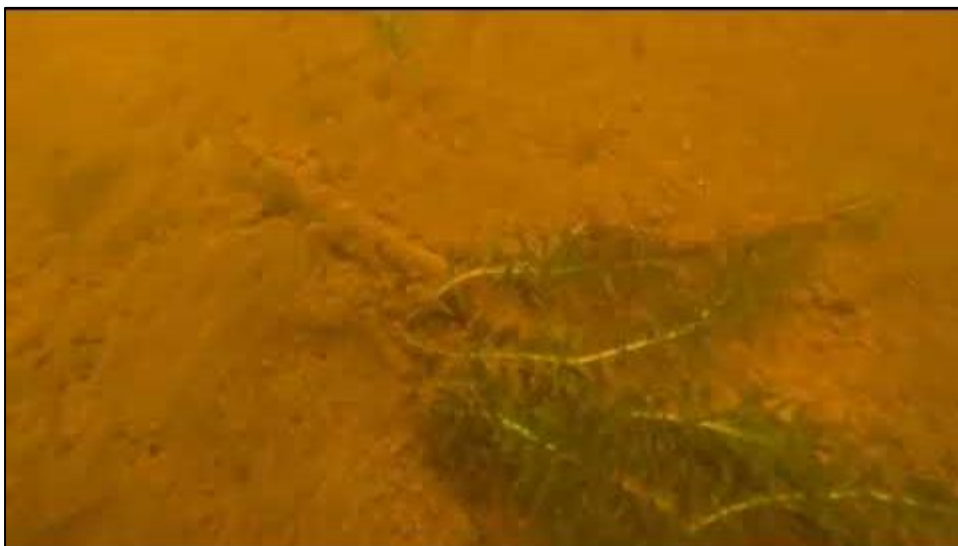
*Utricularia gibba* was also recorded at low covers throughout the emergent reeds. While these invasives do not currently form dense canopies, they represent an ongoing risk. If in-lake conditions shift to favour these species, they could expand rapidly and further suppress native assemblages. *Egeria* is already forming stands across the devegetated sections of the lakebed (Video 4).

**Video 4:** *Egeria densa* stand occupying the devegetated areas of the lakebed.
