# Lake Waiporohita

09/02/2026

NRC Lake Number: 99

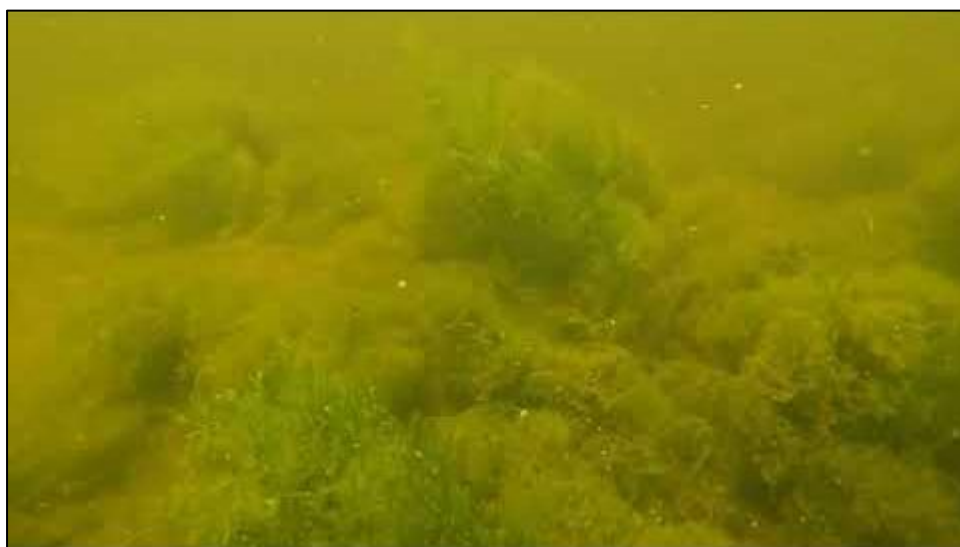
**Video 1:** Charophyte and pondweed dominated macrophyte assemblage.

*Chara australis* is a key structural species, recorded broadly from ~0.3 – 2.4 m and forming moderate (25 – 75%) to very high cover beds (95 – 100%) with average heights ranging from 10 - 55 cm. *Potamogeton ochreatus* is a frequent co-dominant species seen across a similar depth range (~0.3 – 2.4 m), reaching ~48 cm tall and ranging from low (6 - 50%) to very high maximum covers (95 – 100%). *Nitella* sp. aff. *cristata* was the only other charophyte species recorded during the survey and was generally confined to ~0.5 – 0.7 m where it achieved maximum covers 26 – 50%. Shallow turf taxa (*Elatine gratioloides*, *Glossostigma elatinoides*) formed discrete beds in the upper littoral zone (0.1 – 0.4 m) zone. The turf cover along the surveyed transects were low (<25%) however, large beds achieving ~75% cover were seen along the eastern lake margin (Video 2). *Potamogeton cheesemanii* and *Myriophyllum propinquum* were also recorded but did not form significant covers.

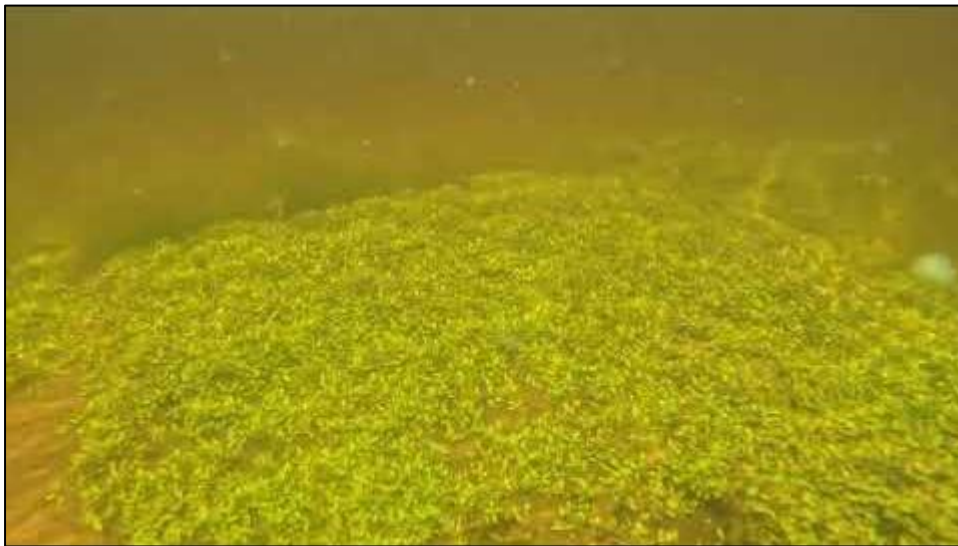
**Video 2:** Turf communities in the upper littoral zone.
