## Poutō Peninsula

Lake Waingata (Poutō), NRC Lake No. 371.

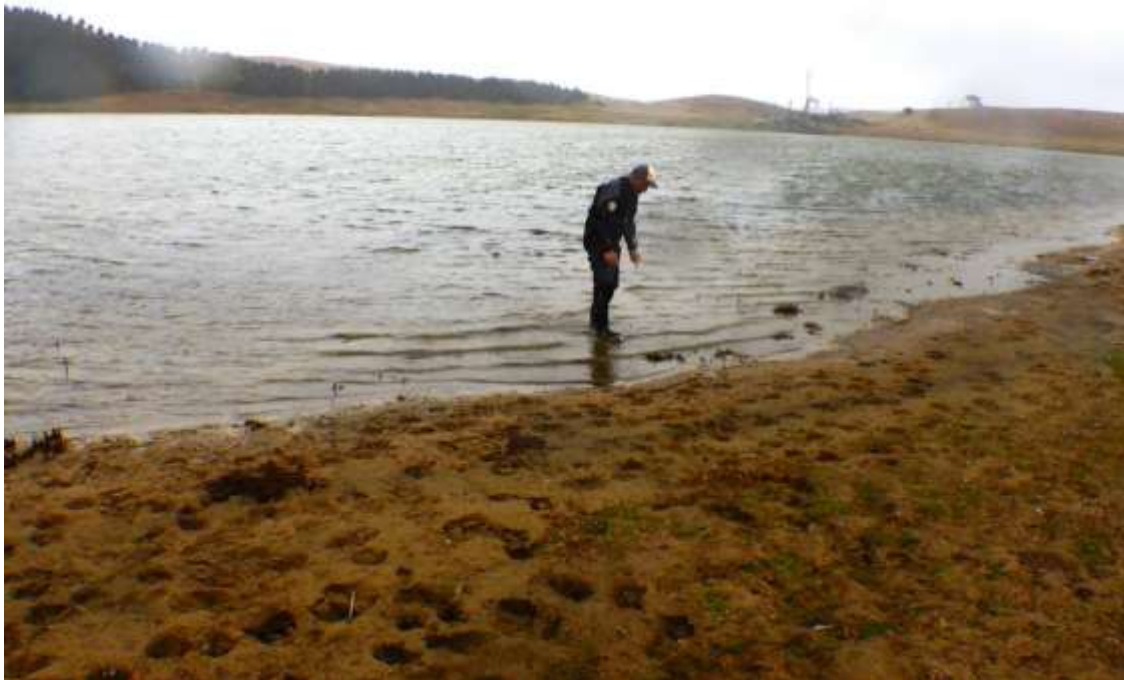
**Lake Waingata:** Livestock access to the lake has destroyed emergent vegetation, note extensive pugging (Mary de Winton 2025).

In 2018, emergent species were noted for the first time since grass carp were stocked, with *Schoenoplectus tabernaemontani*, *Eleocharis acuta*, oioi (*Apodasmia similis*) and *Juncus pallidus*. noted. In 2025, no emergent vegetation was noted, with cattle pugging and grazed emergent beds evident.

Fencing and keeping livestock out of this water body should be advocated to the landowner.

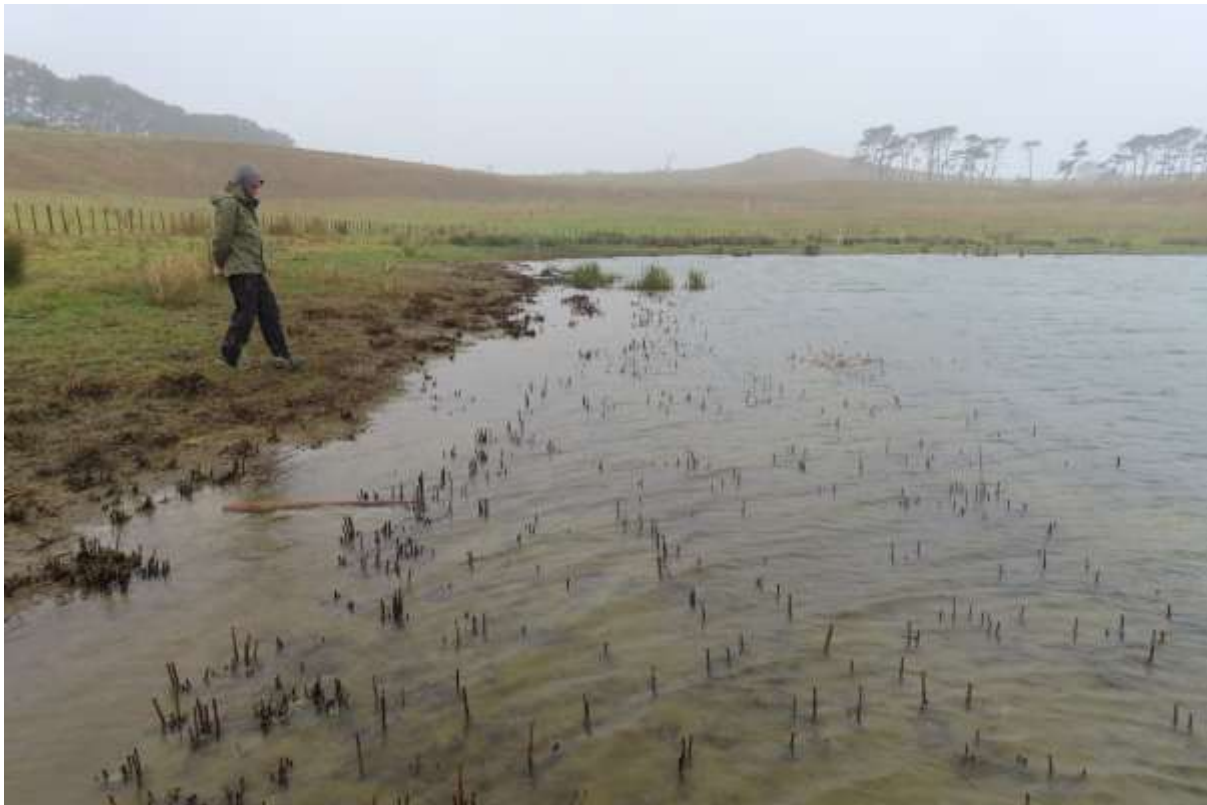
**Lake Waingata:** Grazed emergent vegetation at the eastern end of the lake (Lisa Forester, 2025).

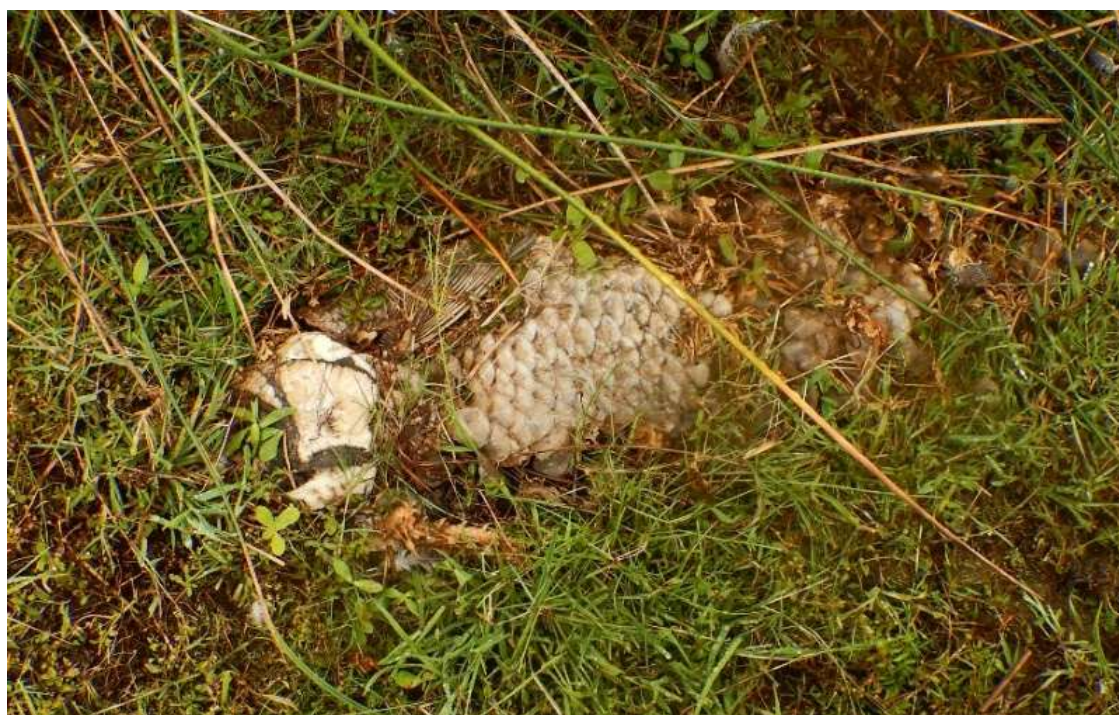
No fish were seen in 2025. The lake was stocked with rainbow trout (*Oncorhynchus mykiss*) in the 1950's until 1980 but are presumed to have since died out. Īnanga (*Galaxias maculatus*) were present in the lake and were recorded as abundant in 1997. Common bully (*Gobiomorphus cotidianus*) were the only other fish present in Waingata until 67 grass carp (*Ctenopharyngodon idella*) were introduced in 1995 to eradicate the pest plant elodea (*Elodea canadensis*) (Rowe et al. 1999). A dead grass carp was noted on the lake margin in 2025.

**Lake Waingata:** Grass carp (*Ctenopharyngodon idella*) corpse on the margin of the lake. Note alligator weed (*Alternanthera philoxeroides*) plants adjacent to the fish (Mary de Winton 2025).
